# ***SIGNAL RECOVERY* Model 3820**

## **Universal Counter Firmware Update Utility**

### **Instruction Manual**

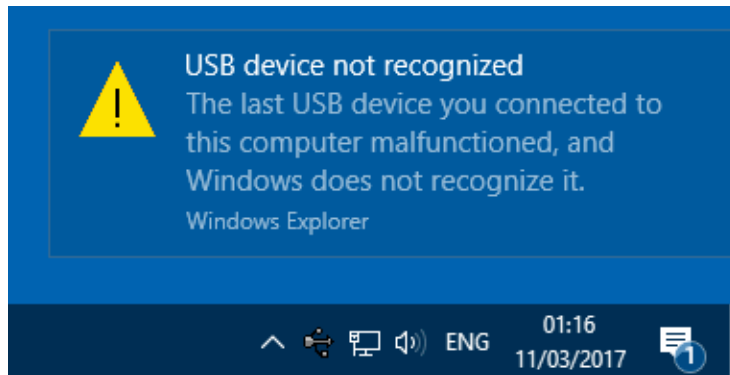
**Figure 1, Error Message**

The ***SIGNAL RECOVERY*** Model 3820 Universal Counter uses internal firmware stored in a programmable memory device. There is a bug in Version A of this firmware whereby when the unit is plugged into the controlling computer it returns an incorrect value in the Configuration Descriptor.

With versions of Windows up to and including Windows 7 this error did not cause a problem, but with versions since Windows 8 and where the computer has more recent USB hardware (especially if this complies with the USB 3.0 specification) then it can mean that the unit is not recognized, making it unusable with these machines.

If the SR3820 Universal Counter software is installed on these computers, then when the counter is connected a message similar to that shown in figure 1 will be displayed.

The program SR3820Update.exe version 1.0 is designed to resolve the problem, by updating the firmware in the connected counter to Version B. Once this has been done the unit will correctly operate on all versions of Windows from XP onwards.

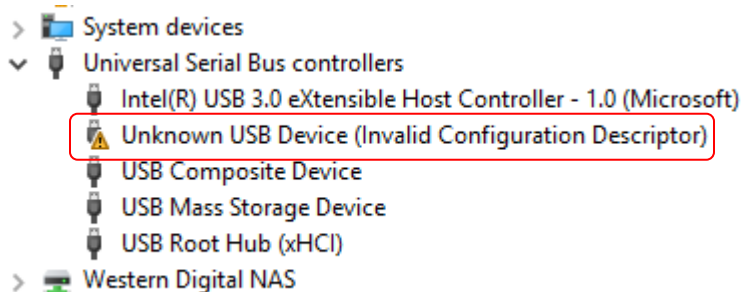
**Figure 2, Device Manager (part listing), with Installation Error**

If Device Manager is opened, then the counter will be shown as an unknown USB device (figure 2).
